How to free an Opti Saw carriage when stuck at top of beam.

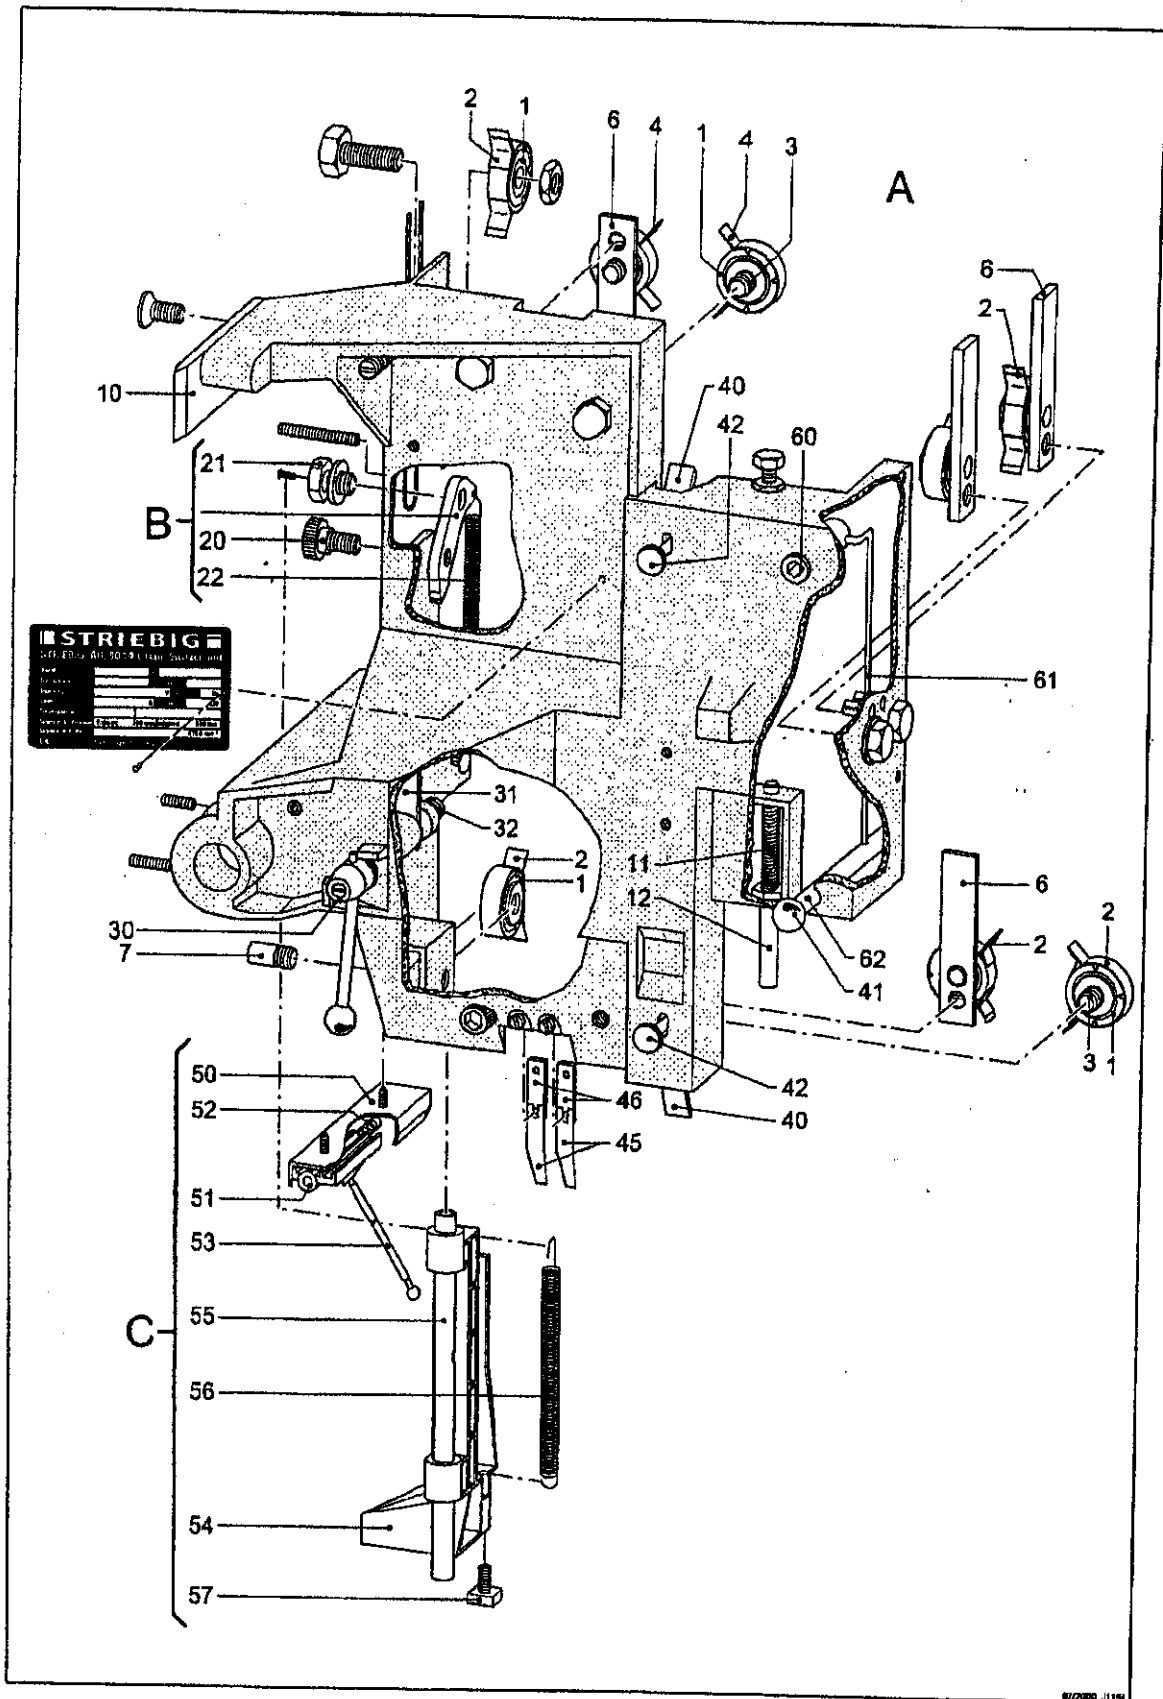
Motorlaufwagen

Situation #2 refers to the emergency brake which is position B in the attached parts breakdown.

Solution: The Emergency brake on this machine is a spring loaded lever intended to rotate into position if there is no tension on the counterweight cables. The weight of the saw carriage forces the lever to bind into the rear ground bearing surface of the left side of the beam. This stops the carriage, protecting both the carriage and the operator. To release the lever the carriage must be pushed up slightly while a second person pulls upwards on the counterweight cables dislodging the lever. The cables can slowly be allowed to return to their natural position and the carriage can be moved down to a normal working height. **Extreme care should be exercised with extra attention paid to protecting fingers when handling the counterweight cable. Pinching a finger with a 200lb.counterweight on the other end of the cable can cause physical damage!**

After freeing the saw carriage examine the rear of the ground bearing surface where the Emergency brake lever had made contact. You will find disruptions in the surface. Use a flat file to remove the disruptions. Failure to do so will result in repeated locking up of the saw carriage!
